# Eco Electrical Systems

1000 h Salt Fog Test per IEC 62217:2012

## REPORT OF PERFORMANCE

| TEST SPECIFICATION | IEC 62217:2012, Clause 9.3.3 |

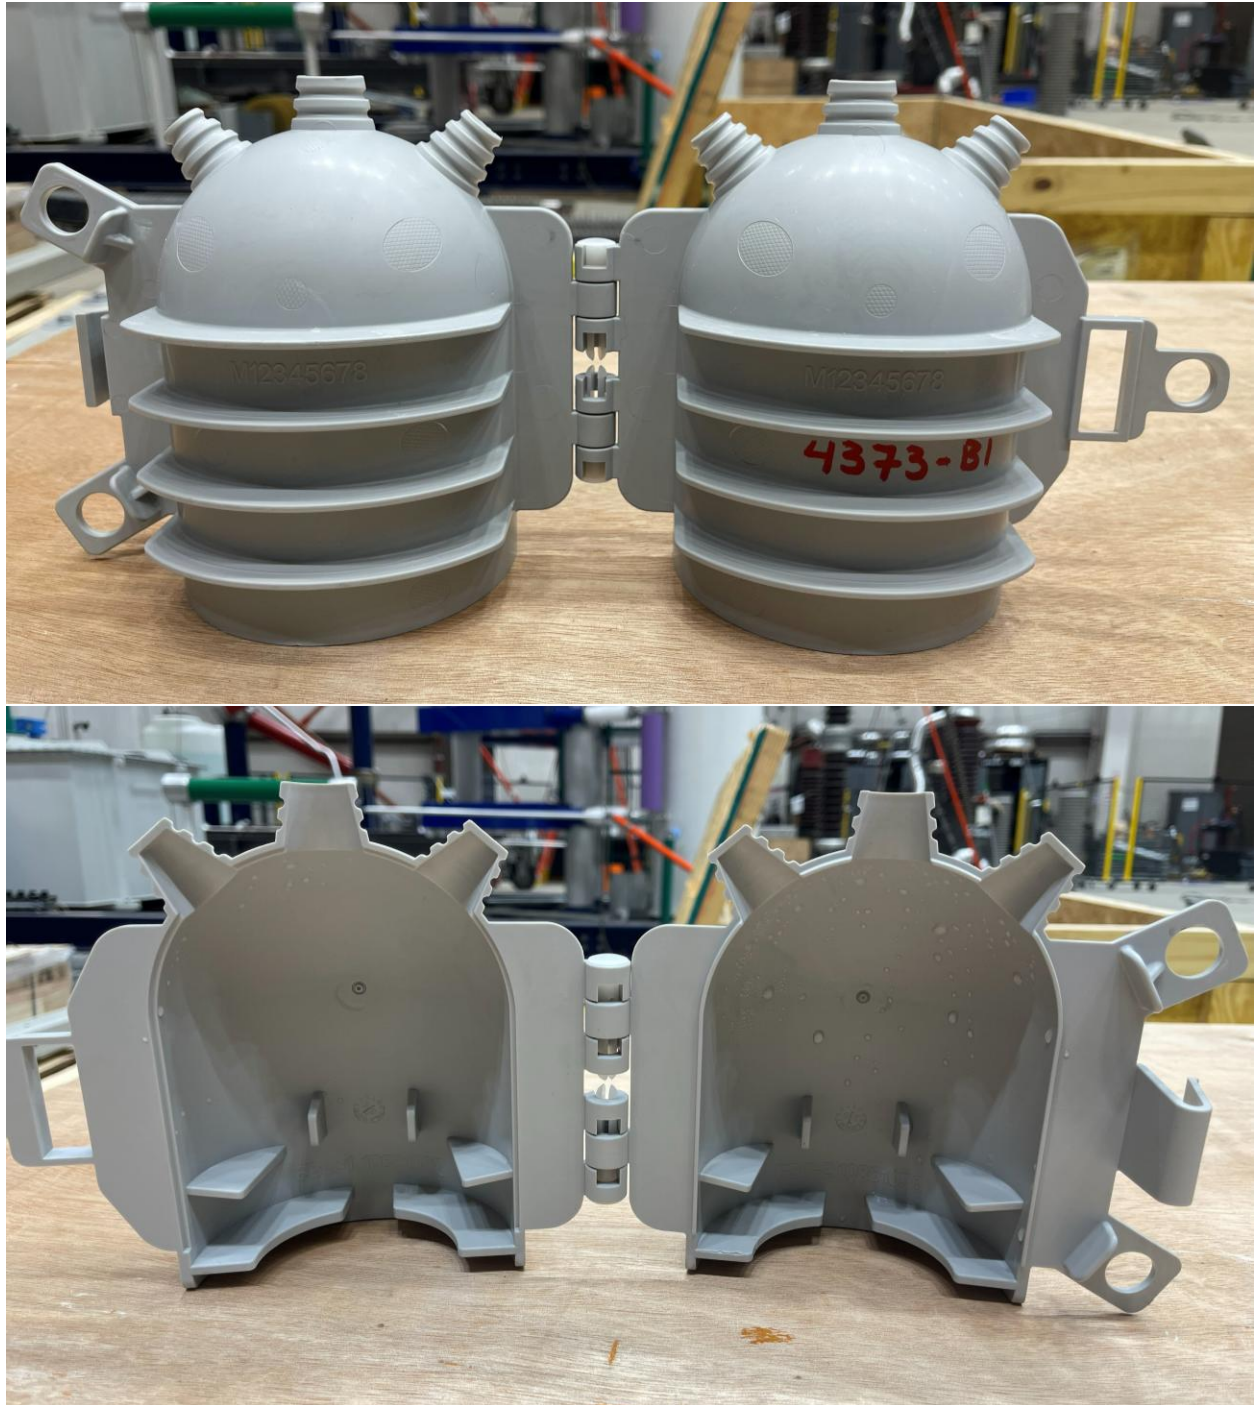
Figure 6 – Sample B-1 after the test.

| Sample number | Type | Evaluation | Figures | Result |
|---|---|---|---|---|
| B-1 | Bushing cover | No measurable amounts of tracking or erosion, and no sheds, housing, or interfaces were punctured. | Figure 6 | PASS |

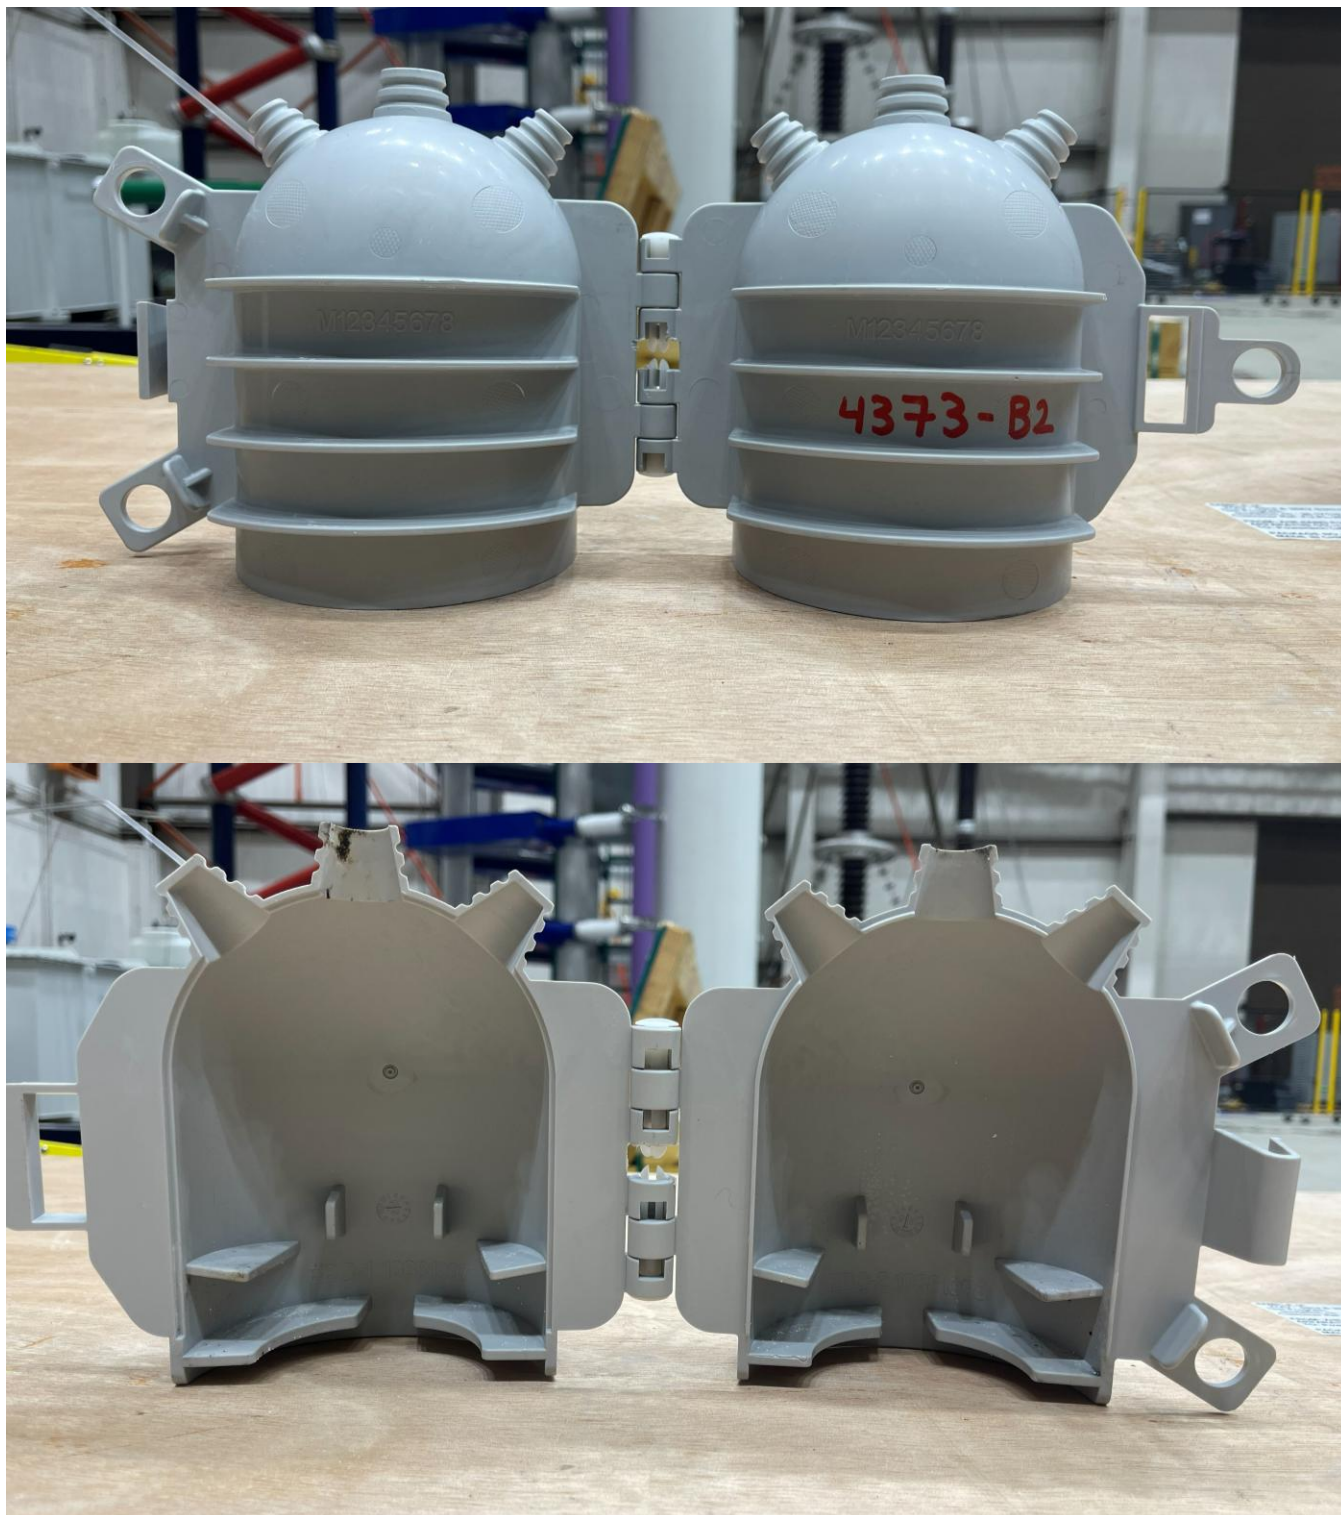
Figure 7 – Sample B-2 after the test.

| Sample number | Type | Evaluation | Figures | Result |
|---|---|---|---|---|
| B-2 | Bushing cover | No measurable amounts of tracking or erosion, and no sheds, housing, or interfaces were punctured. The topmost inner edge of the bushing cover showed a black stain created from the tracking and erosion of the high voltage conductor contained within, however no tracking or erosion were noted on the sample itself. | Figure 7, Figure 8 | PASS |

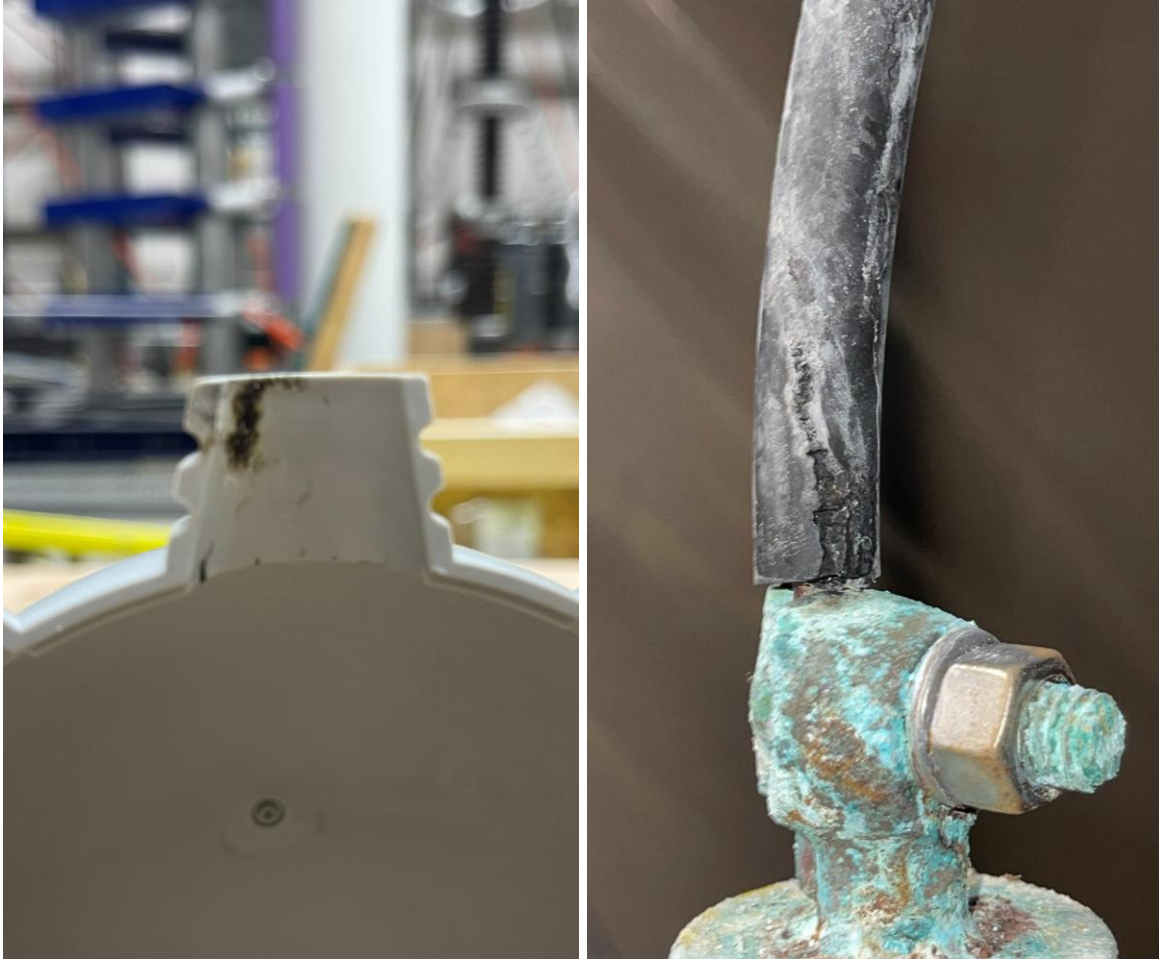
Figure 8 – Detail of stain in Sample B-2 (left), where no tracking or measurable erosion were present, and cable that eroded (right) causing the black stain on the sample.

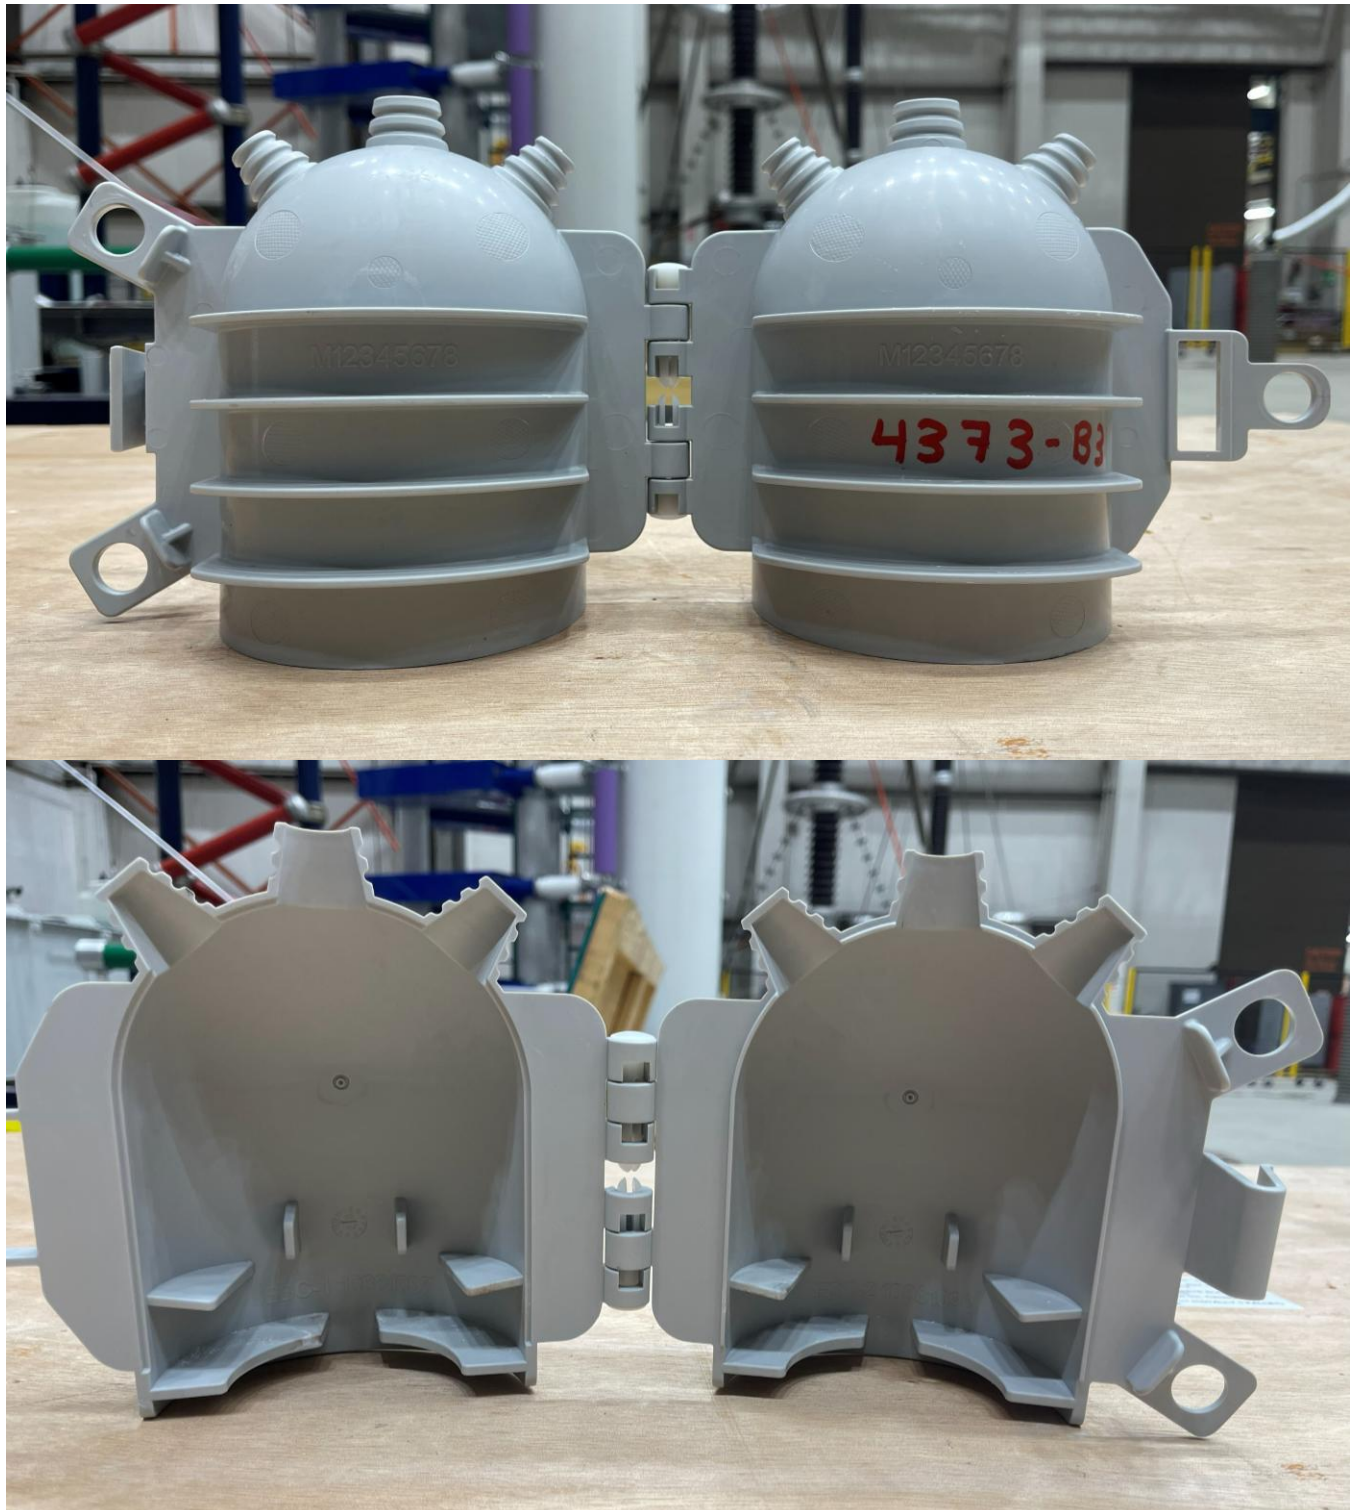
Figure 9 – Sample B-3 after the test.

| Sample number | Type | Evaluation | Figures | Result |
|---|---|---|---|---|
| B-3 | Bushing cover | No measurable amounts of tracking or erosion, and no sheds, housing, or interfaces were punctured. | Figure 9 | PASS |

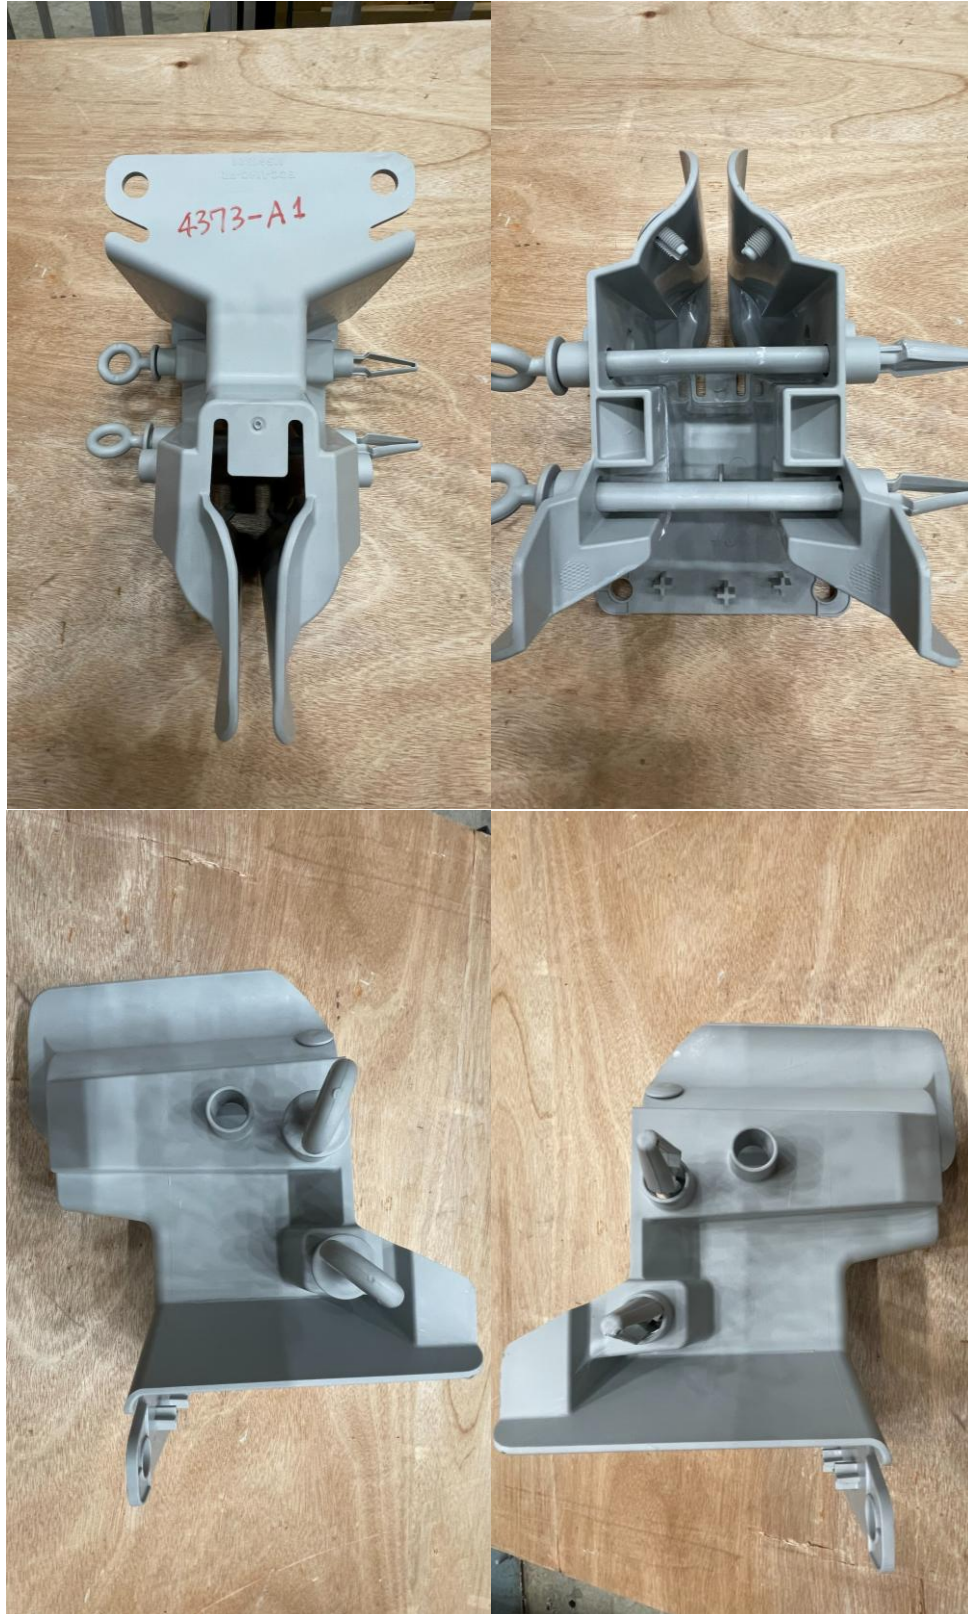
Figure 10 – Sample A-1 after the test.

| Sample number | Type | Evaluation | Figures | Result |
|---|---|---|---|---|
| A-1 | Cutout cover | No measurable amounts of tracking or erosion, and no sheds, housing, or interfaces were punctured. | Figure 10 | PASS |

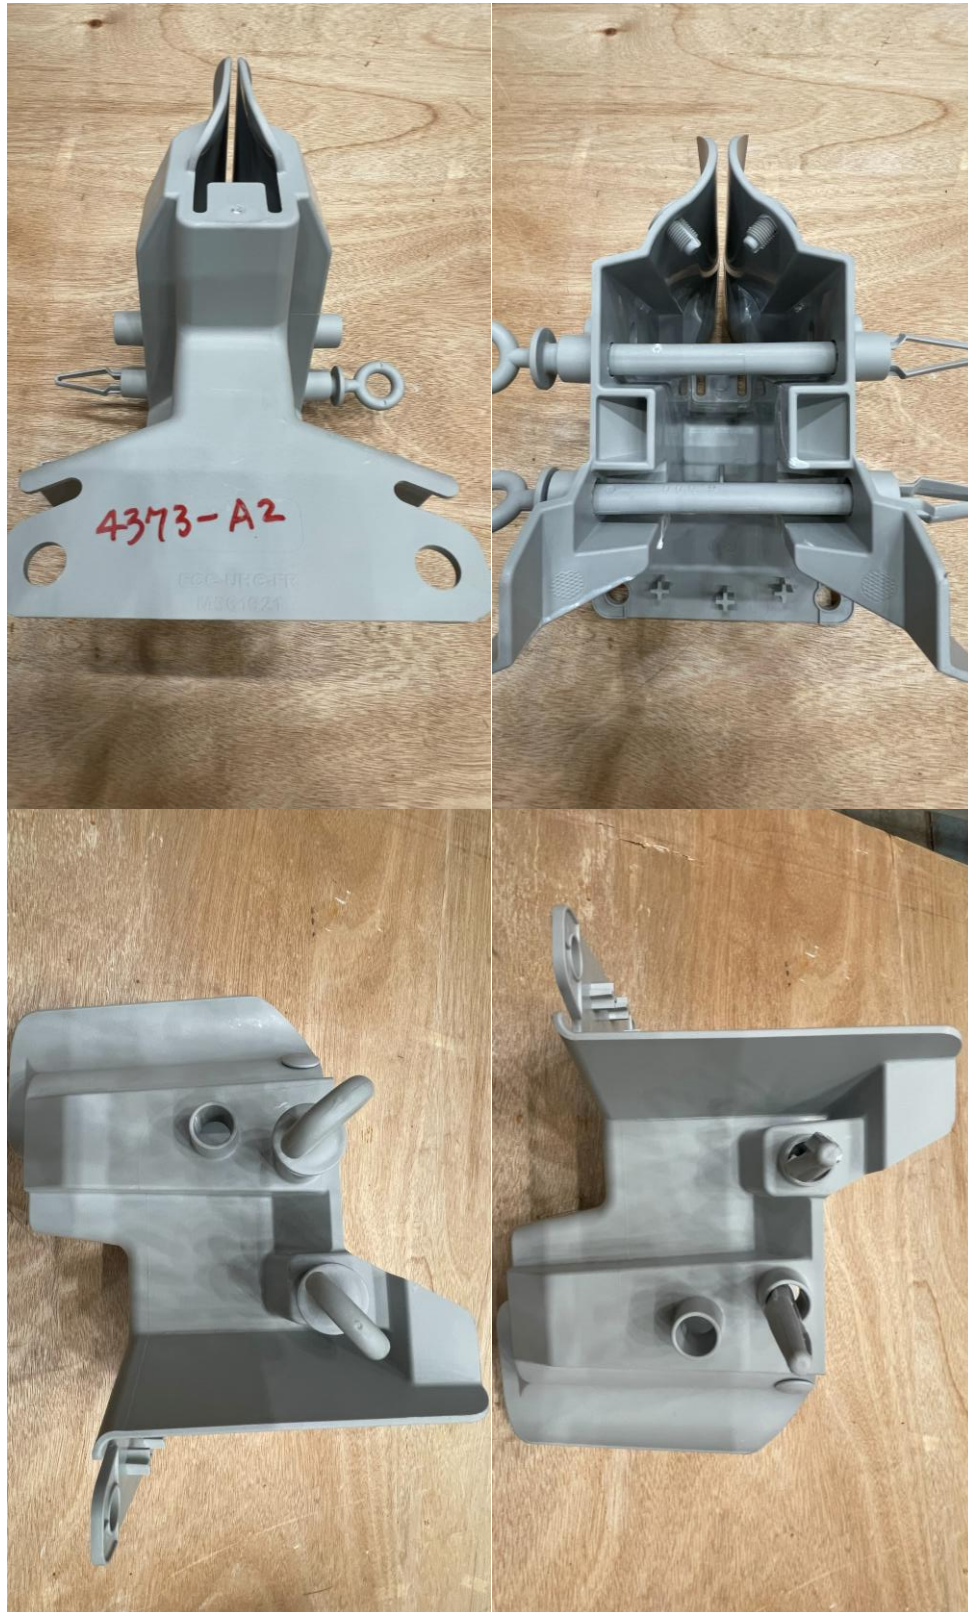
Figure 11 – Sample A-2 after the test.

| Sample number | Type | Evaluation | Figures | Result |
|---|---|---|---|---|
| A-2 | Cutout cover | No measurable amounts of tracking or erosion, and no sheds, housing, or interfaces were punctured. | Figure 11 | PASS |

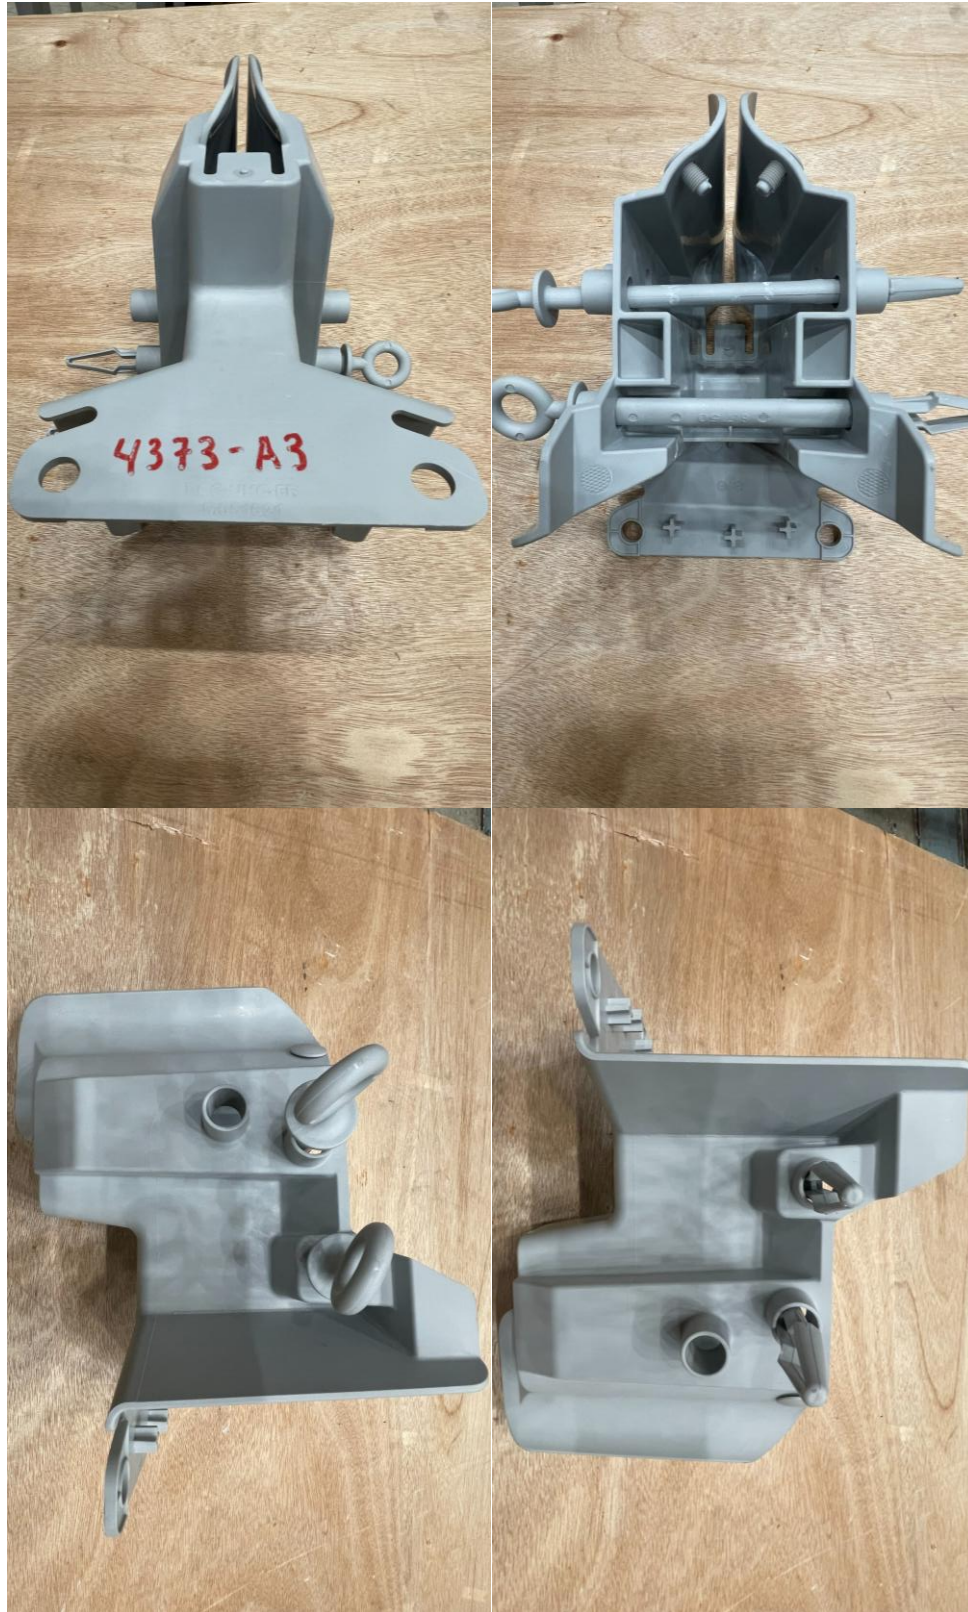
Figure 12 – Sample A-3 after the test.

| Sample number | Type | Evaluation | Figures | Result |
|---|---|---|---|---|
| A-3 | Cutout cover | No measurable amounts of tracking or erosion, and no sheds, housing, or interfaces were punctured. | Figure 12 | PASS |
