ECC-UHC-FR Cutout Wildlife Protective Covers IEEE 1656-2010

REPORT OF PERFORMANCE

CLIENT/MANUFACTURER Eco Electrical Systems 7635 Rocky Flats Ct. Reno, NV USA 89502 **TEST OBJECT** ECC-UHC-FR Cutout Cover System Voltage: 27 kVrms **TESTED BY** Powertech Labs Inc. 12388 - 88th Ave, Surrey, BC Canada V3W 7R7 www.powertechlabs.com DATE RECEIVED 2020-11-30, 2021-03-17 TEST DATE(S) 2021-01-12 to 2021-04-06 **TEST SPECIFICATION** IEEE 1656-2010, Clauses 5.2, 5.3, 5.4, 5.9.3 **TEST RESULT PASS** Powertech Labs Inc. does not accept any liability for any damages resulting from the use of this report. The results relate only to the item(s) tested as received, and it is the responsibility of the manufacturer to maintain conformity of any object having the same designations. Information regarding the estimated measurement uncertainty is available upon request. The test report shall not be reproduced except in full, without written approval of Powertech Labs Inc. Prepared by: Reviewed by: Alex Webb, EIT Logan Connaughton, P. Eng

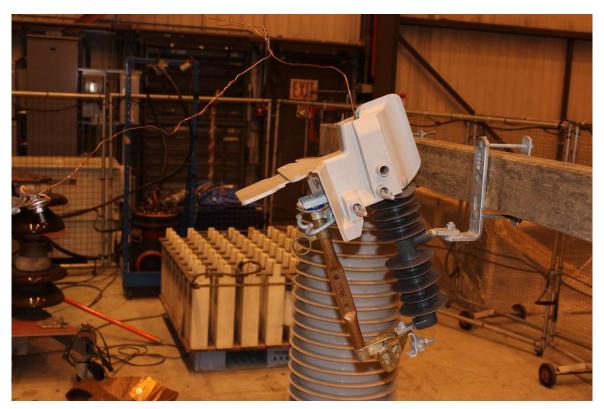
Figure 7. Lightning impulse withstand test setup

Three ECC-UHC wildlife protective covers were mounted, one at a time, on to a Hubbell 27 kV, 150 kV BIL polymer fuse cutout. The fuse cutout and cover were then subjected to 3 positive and 3 negative lightning impulses with the fuse cutout in each of the following configurations:

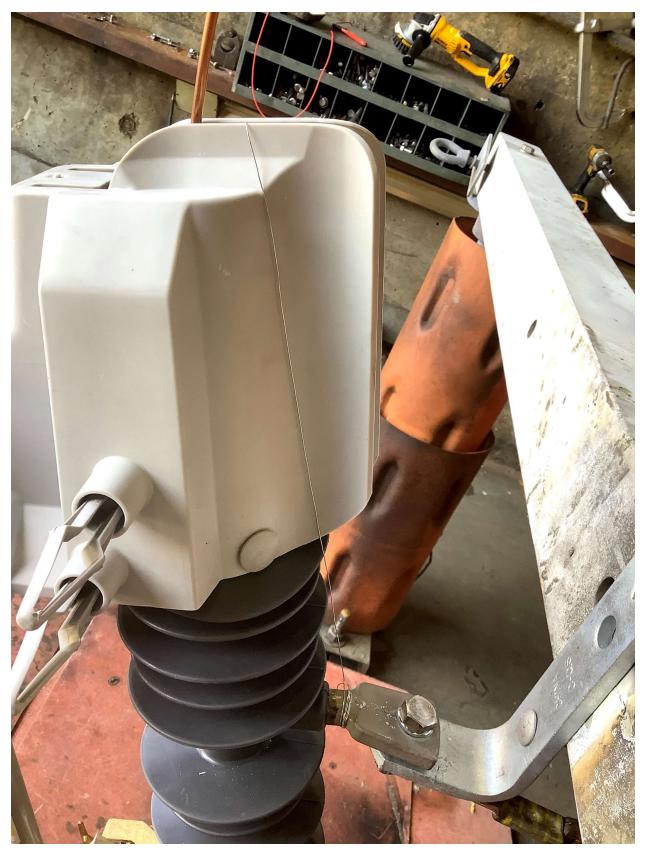
Figure 11. Setup for the high current (power arc) tests, fuse wire.

In each test, the source side terminal of the cutout was connected to lab power source with #6 AWG bare copper wire; the mounting bracket was connected to lab ground; the load side terminal of the cutout was not connected. A #24 AWG copper fuse wire was installed across the surface of the wildlife guard sample, between the source side terminal of the cutout and the mounting bracket bolt. Pictures of the test setup are provided in Figures 7 and 8.

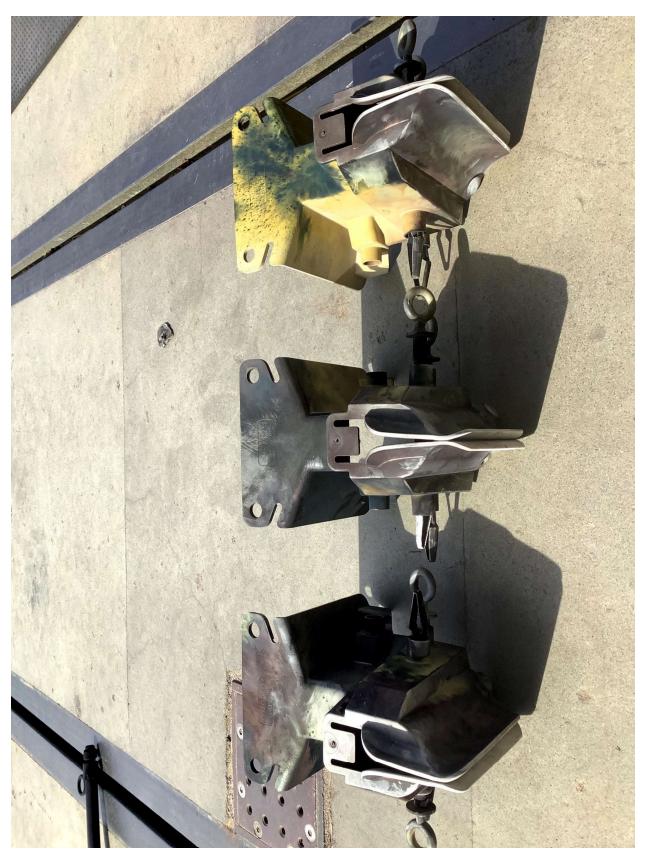
Figure 12. Samples after the high current (power arc) tests.

The three samples completed the tests with no flames or signs of melting. A picture of the samples after tests is provided in Figure 12
