Report ID: PL-03573 REP2
Revision: 1 Issued: 2021-07-19

Eco Electrical Systems

ECC-10UC-FR Cutout Wildlife Protective Covers
IEEE 1656-2010

REPORT OF PERFORMANCE

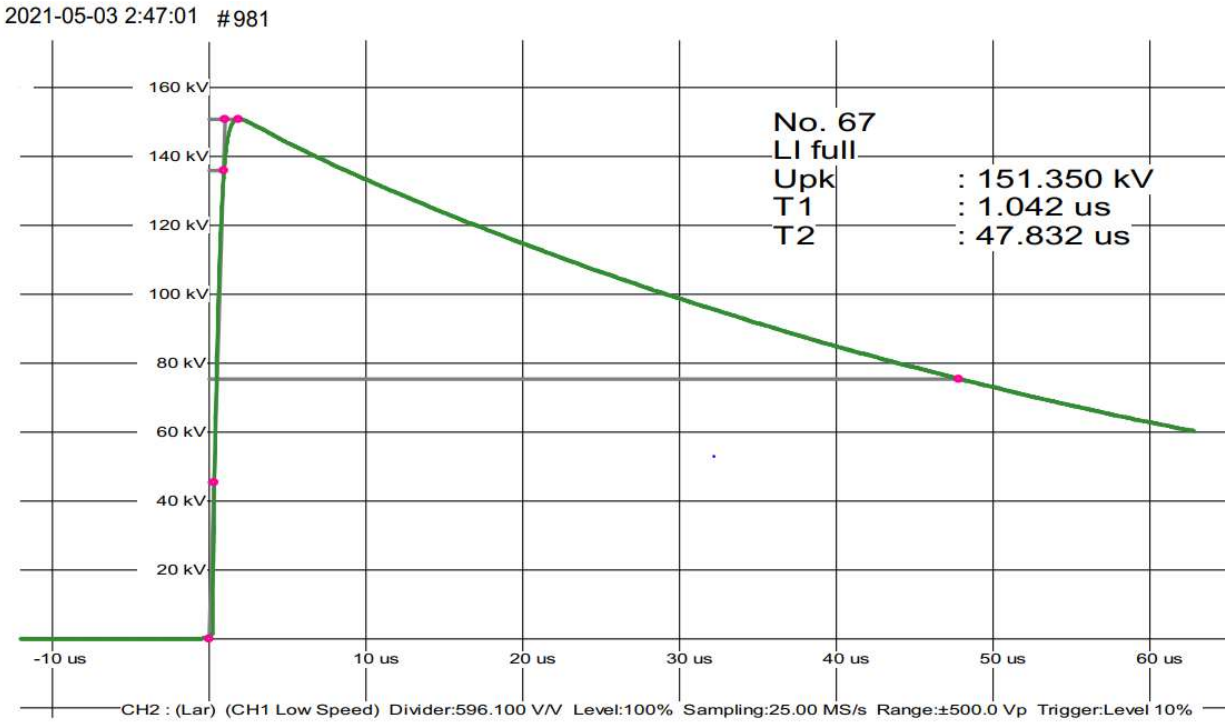
Figure 1. Example positive lightning impulse waveform

Evaluation:
No flashovers were observed. The test fixture and wildlife protective covers withstood all impulses.

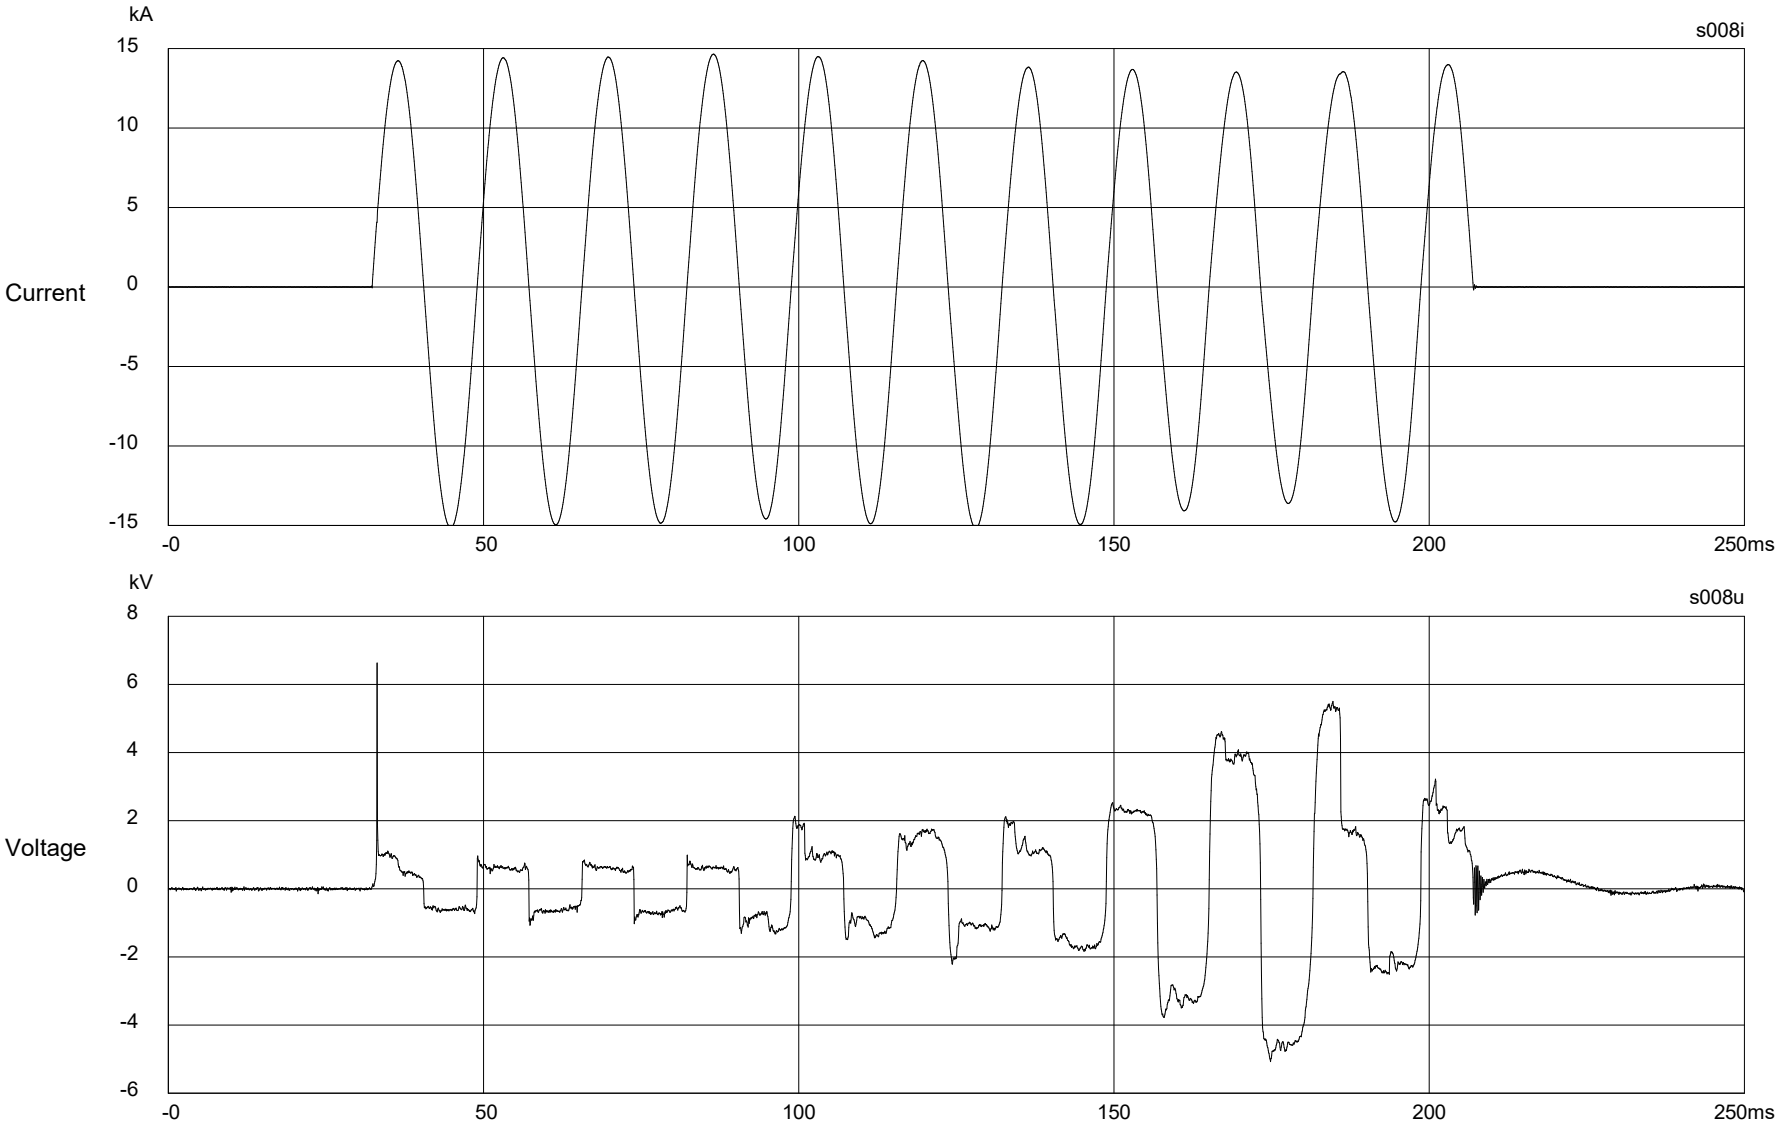
Figure 4: Waveforms for Test #1 on sample #2276-4A.

Test No.	Sample No.	Source Voltage [kV_{rms}]	Current		Waveform
			Symmetrical [kA_{rms}]	Duration [ms]	
#1	2276-7B	15.9	10.2	175	Figure 4
#2	2276-8B	15.9	10.3	175	Figure 5
#3	2276-9B	15.9	10.3	175	Figure 6

Evaluation:
The three samples completed the tests with no flames or signs of melting. A picture of the samples after the test is provided in Figure 11.

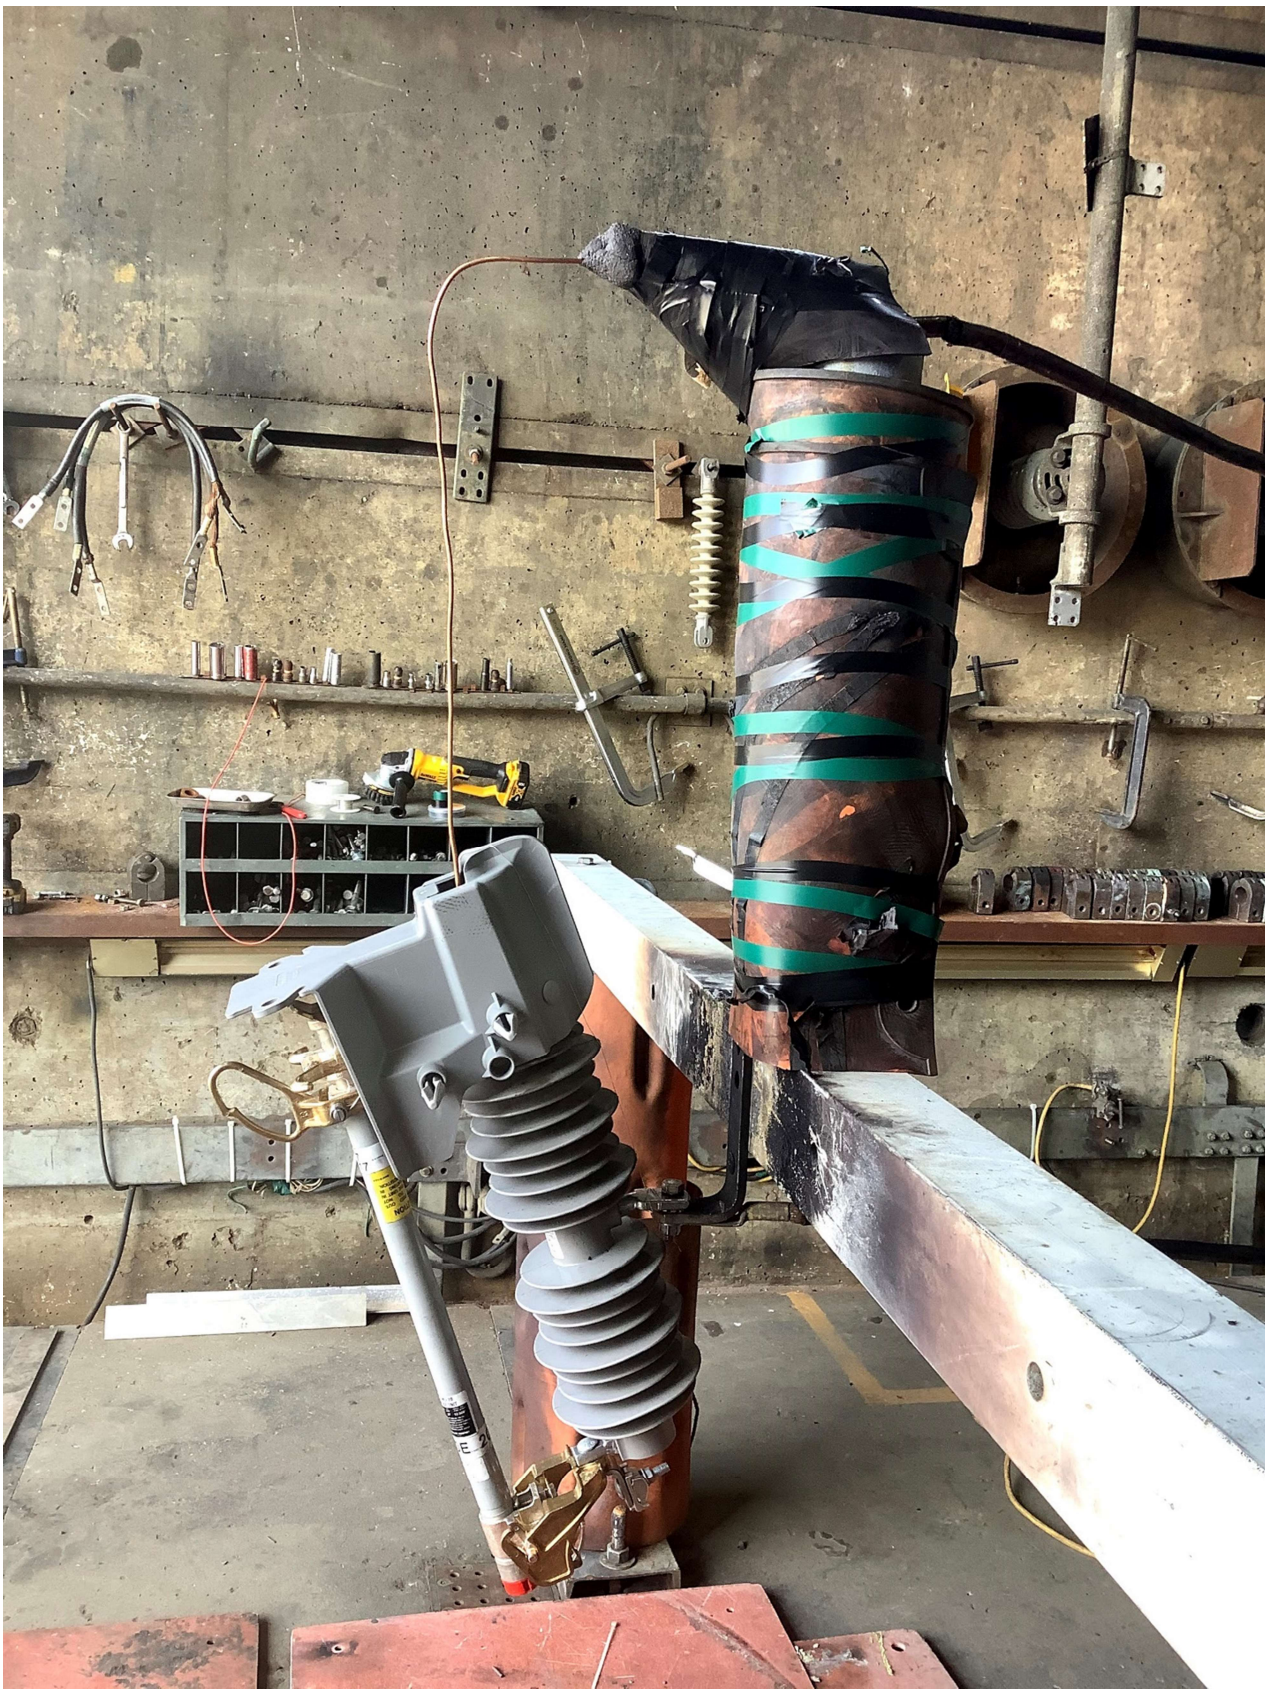
Figure 10: Setup for the high current (power arc) tests.

In each test, the source side terminal of the cutout was connected to the lab power source with #6 AWG bare copper wire; the mounting bracket was connected to lab ground; the load side terminal of the cutout was not connected. A #24 AWG copper fuse wire was installed across the surface of the wildlife guard sample, between the source side terminal of the cutout and the mounting bracket bolt. Pictures of the test setup are provided in Figures 7 and 8.
